An ALTON-alternative Oil Seal for a Comet

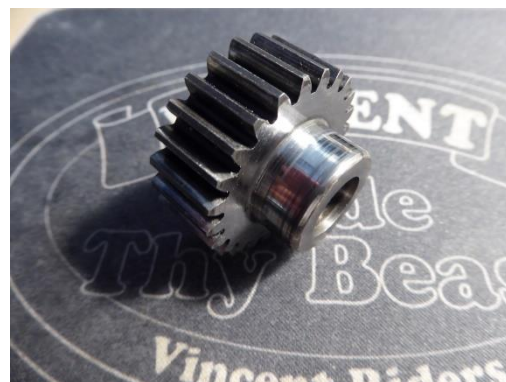
Pictured is E228 where you can easily see the 'surface' that mates with E224 making a very effective and long lived oil seal. It is of note that this type of seal relies in part on the rotating surface to be highly polished – smooth.

Readers may remember that on the Comet the way the factory sealed the Miller generator was by means of E224, a lipped seal, that is a press fit into the crankcase and runs on the shoulder of the dynamo pinion E228.

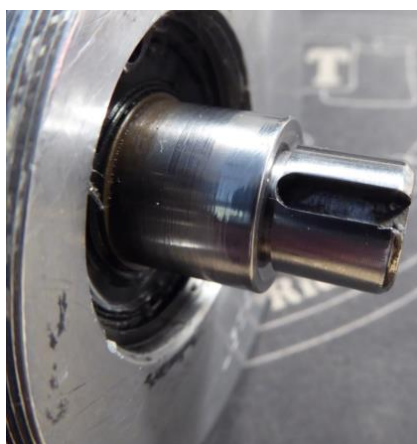
Here is a picture of the drive end of my Alton. Look carefully and you will note the diameter of the drive shaft is largest where it exits the alternator body and it is then reduced in diameter to accommodate the drive gear. This photo was taken after I had polished the larger diameter part of drive shaft (done without disassembly of the ALTON) ensuring the lipped seal had a smooth sealing surface.

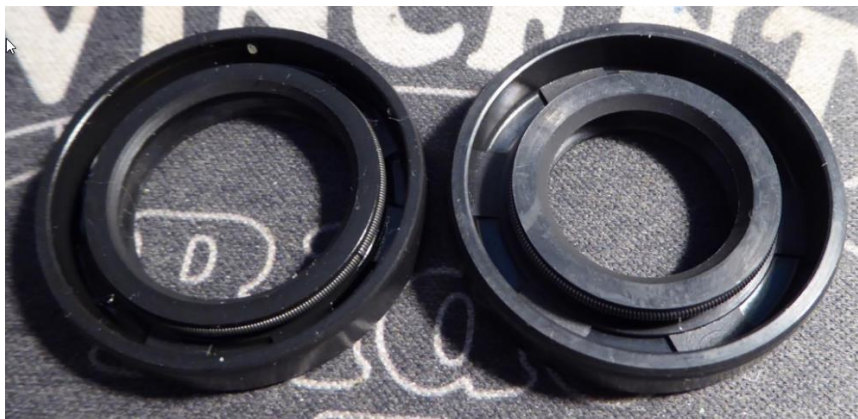
Pictured here is the original E224 used in conjunction with the Miller generator, alongside it (right) is the new 18-35-7 seal for use with the ALTON. When installed the side with the garter spring MUST be on the oil source side.

found was a lipped seal with the description "Seal 18-35-7"; this has an ID of 18mm which is perfect for the ALTON drive shaft, and an OD of 35 mm which is just 0.075mm larger than the 1 3/8" crankcase opening and has a depth of 7mm.

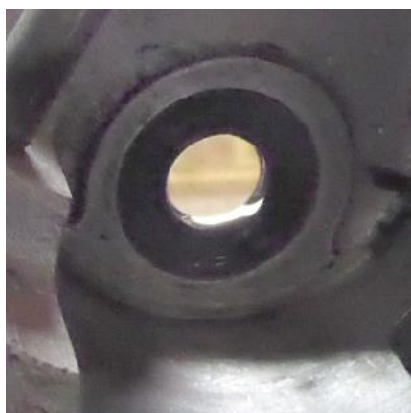
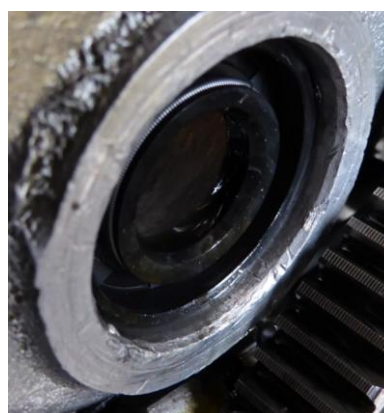
Here is the new seal, left from outside the crankcase, and right, from the timing chest side.

Keeping in mind that when installed, the end of the ALTON is to be flush against the outside surface of the crankcase I installed the new seal so that the back of it was just below the outside surface of the crankcase – by about 1/16", thus ensuring the ALTON would mount flush as intended. The seal is a firm press fit into the crankcase opening and I used a suitable drift and light hammer to get the seal into the exact position sought, making sure it was not cocked in the opening.

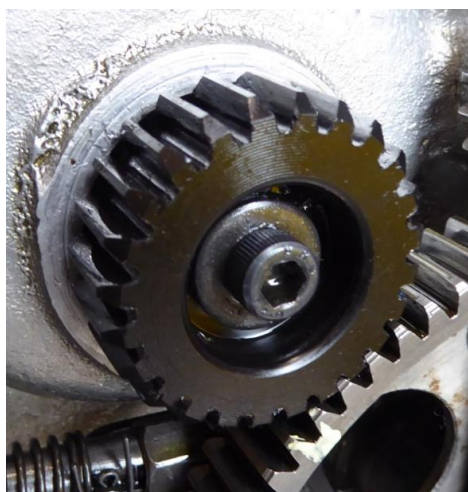
Lipped seals ONLY work if there is a thin film of oil on the bearing surfaces, so be sure, as I did, to have a quantity of clean fresh oil on the seal surfaces as you assemble things. All that remained was to slip the ALTON into position taking care to keep the drive shaft central within the lipped seal as lipped seals will NOT last long if the sealed shaft is not central and running true. The final photo is with all in place, ready for the timing cover to go back on.

After over 200 miles of on road testing with the new setup in my Comet I can report that the ALTON installation remains oil tight!
