Chasing Down A Burman Leak

There are just a few places where oil/grease can leak from the outer case of a Burman BAP gear box and one of those places is where the gear change shafts pass through it.

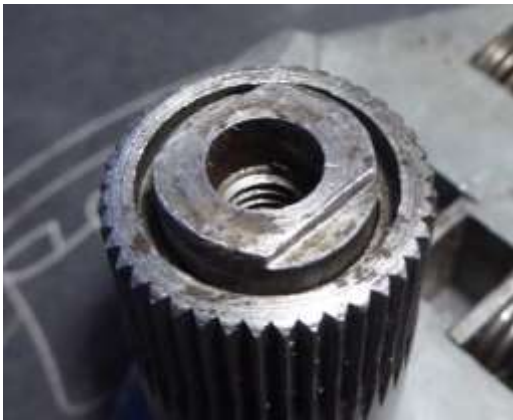
In OVR #36 Bernhard Kurschel described how to effectively fit an internal oil seal to the gear change shaft carrier. While this tamed at least 80% of the oil leaking from the gear change area, some traces of oil was still able to find its way to the outside world along the tiny space between PR50-C-094 the ratchet foot change sleeve and the inner PR50-C-090 sector spindle.

Wanting to eliminate this remaining small leak I closely examined the components in the gear change area and immediately noticed the space at the outer end of the gear change shaft assembly that look suited to an 'O' ring.

From my parts stock I found that a 5/16" OD x 1/16" cross section 'O' ring could be easily persuaded into the groove between the two shafts (picture above). As the back of the Gear Indicator PR50-C-097-1 sits on the shoulder of the inner shaft and proud of the outer sleeve as shown on the right - without some form of retainer there is the opportunity for any such 'O' ring to work its way upwards and lose sealing effectiveness. My solution to this was to modify a 0.015" shim that I had on hand so that it would fit over the inner shaft but inside the hole in the gear change lever, so acting as a retainer for the 'O' ring; as shown in the images below. It is essential that when installed the face of the shim is a few thou' below the shoulder on the sector spindle.
